FIELD APPROVAL PIRS US03340605173

## MAJOR REPAIR AND ALTERATION (Airframe, Powerplant, Propeller, or Appliance)

<b>1. Aircraft</b>	Make New Piper	Model PA-28RT-201
	Serial No. 28R-7918096	Nationality and Registration Mark N2249X
<b>2. Owner</b>	Name (As shown on registration certificate) ELWOOD, ANDREW D.	Address (As shown on registration certificate) 9 PARKER TERRACE ESSEX, CT 06426-1060

PIPER PA28RT-201 S/N 28R-7918096 N# 2249X TT: 4378 hrs. DATE: 20 OCT 05

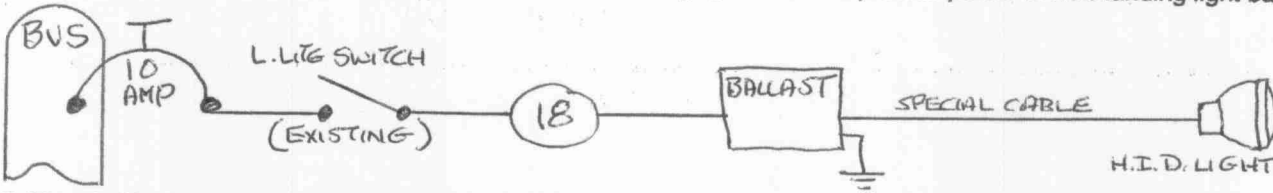
2. Utilized existing wiring, 10 amp circuit breaker, and landing light switch to provide power to new landing light ballast.

1. Replaced original aircraft landing light (GE4509) in lower/middle engine cowling with XeVision High Intensity landing light Kit# XV-36-SL H.I.D.
