MAJOR REPAIR AND ALTERATION (Airframe, Powerplant, Propeller, or Appliance)

1. Aircraft	Make New Piper Aircraft	Model PA-28R-200
	Serial No. 28R-35698	Nationality and Registration Mark N4979S
2. Owner	Name (As shown on registration certificate) Dunn James J	Address (As shown on registration certificate) 901 Telford Lane Petaluma, Ca. 94954

with XeVision H.I.D. Replacement Landing Lights in RMD Wingtips

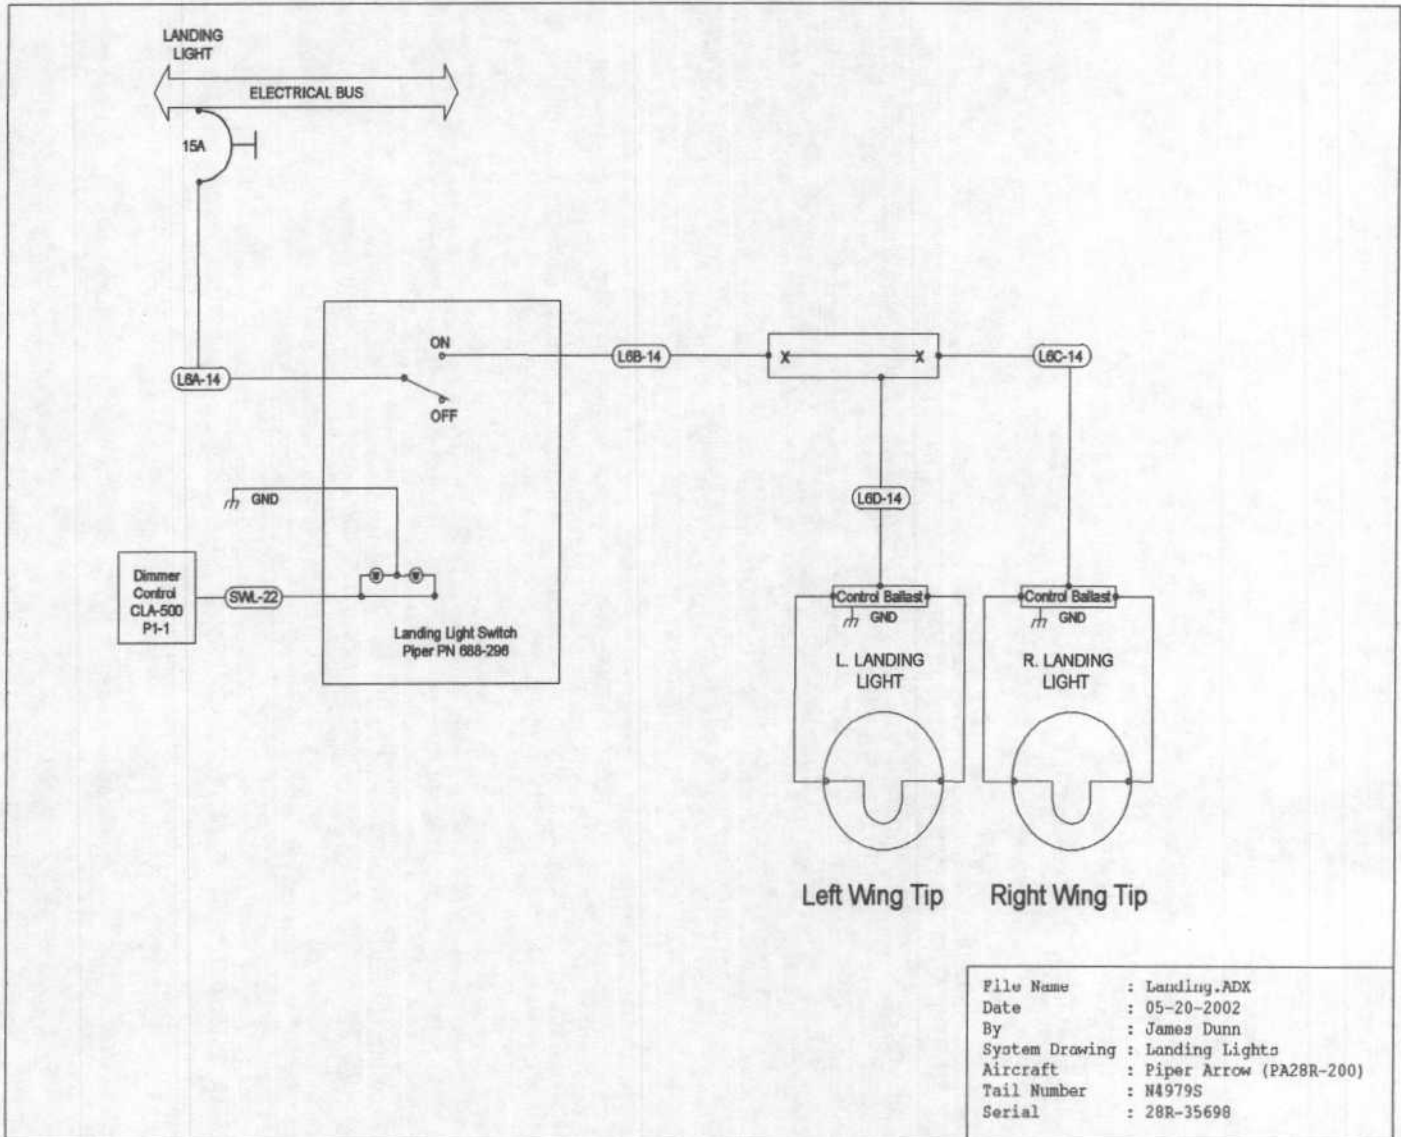
Landing Light Wiring Diagram

2. **Description:** Each XeVision light was installed in replacement for two Par36 landing lights 1 in each wingtip. The ballasts are mounted on the outboard side of end rib adjacent to end of spar used existing wire and circuit breaker installed with the RMD wing tip STC.
