MAJOR REPAIR AND ALTERATION (Airframe, Powerplant, Propeller, or Appliance)	Form Approved OMB No. 2120-0020
		For FAA Use Only
		Office Identification

1. Aircraft	Make Beechcraft	Model 35-33
	Serial No. CD	Nationality and Registration Mark N638
2. Owner	Name (As shown on registration certificate)	Address (As shown on registration certificate)
		P.O. Box 398 Cordell OK. 73632

Installed XeVision High Intensity discharge Xenon landing light lamp system in existing location of landing light in nose bowl.

Instructions for Continued Airworthiness
For a Beechcraft 35-33 Aircraft
With XeVision H.I.D. Replacement Landing Light in Nose bowl.

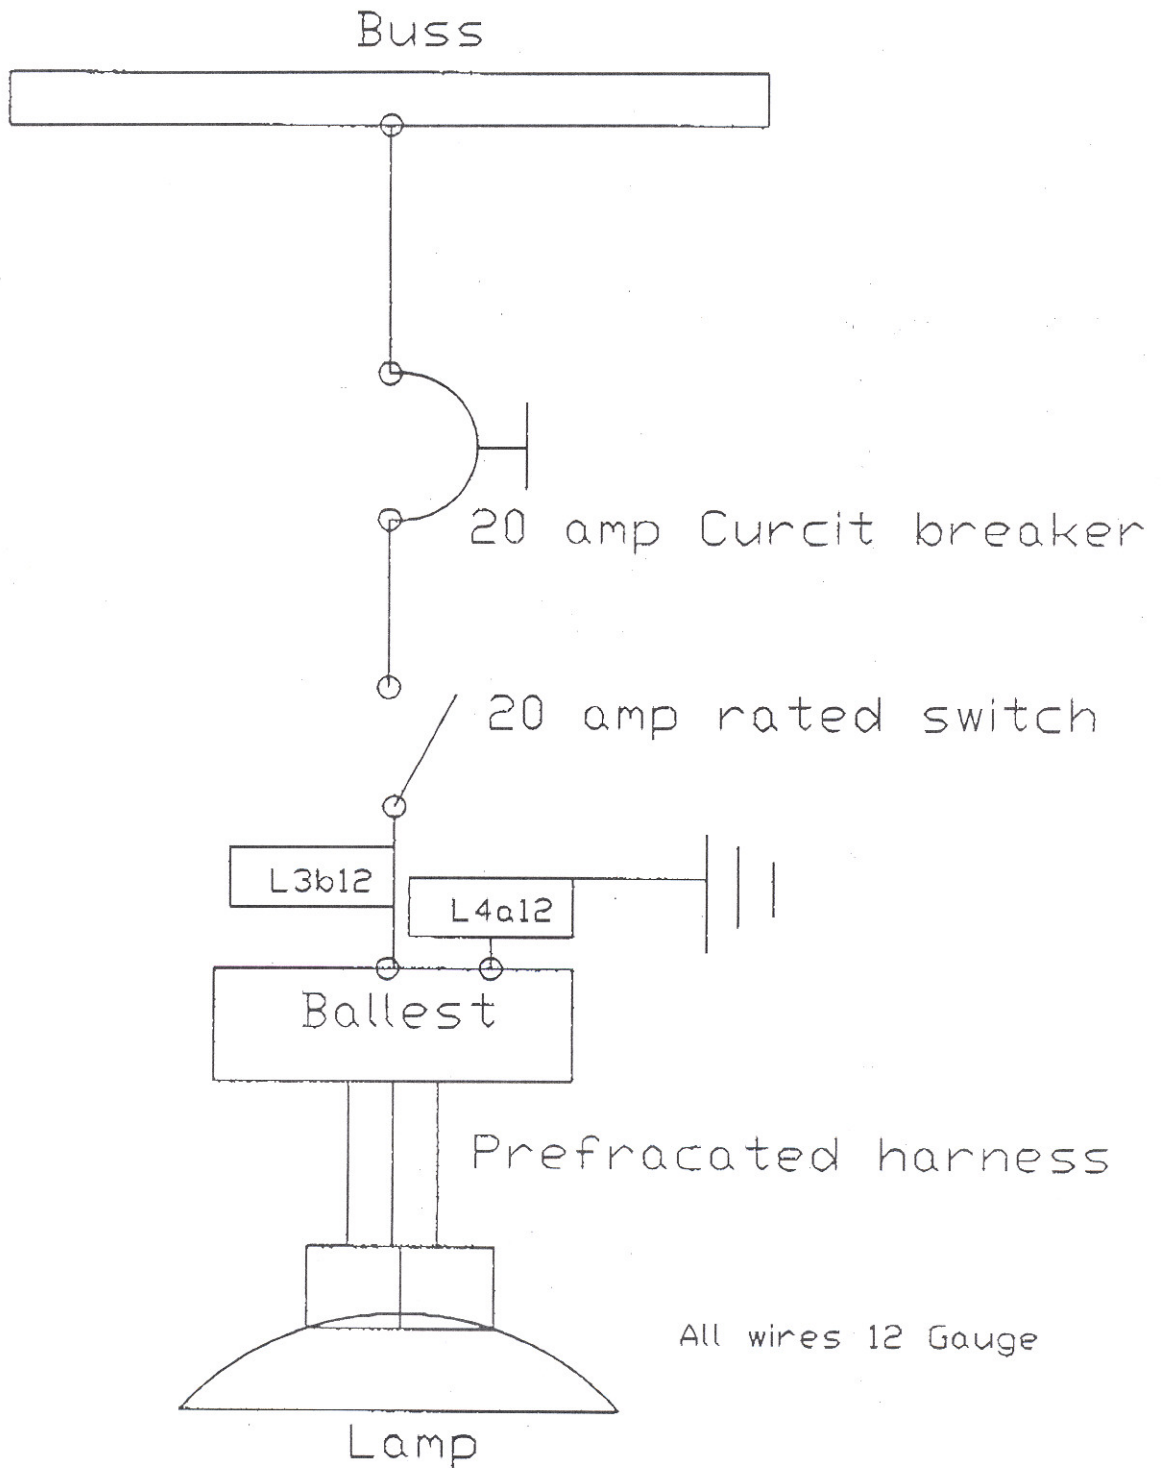
Landing Light Wiring Diagram

4. Mounting of Electronic controller is by (3) AN3-10A bolts and (3) AN365-1032 nuts with (3) AN970-3 large area washers on the rear.
5. Existing wiring from original light was retained as it exceeds the requirement of new light see attached drawing.
