8. Description of Work Accomplished

C177B 17702359 N999HR 1/10/2007 2309 tach Hrs.

N999HR ser.# 17702359 • Cessna Cardinal 177B • 2309 tach hrs. • 1/10/2007

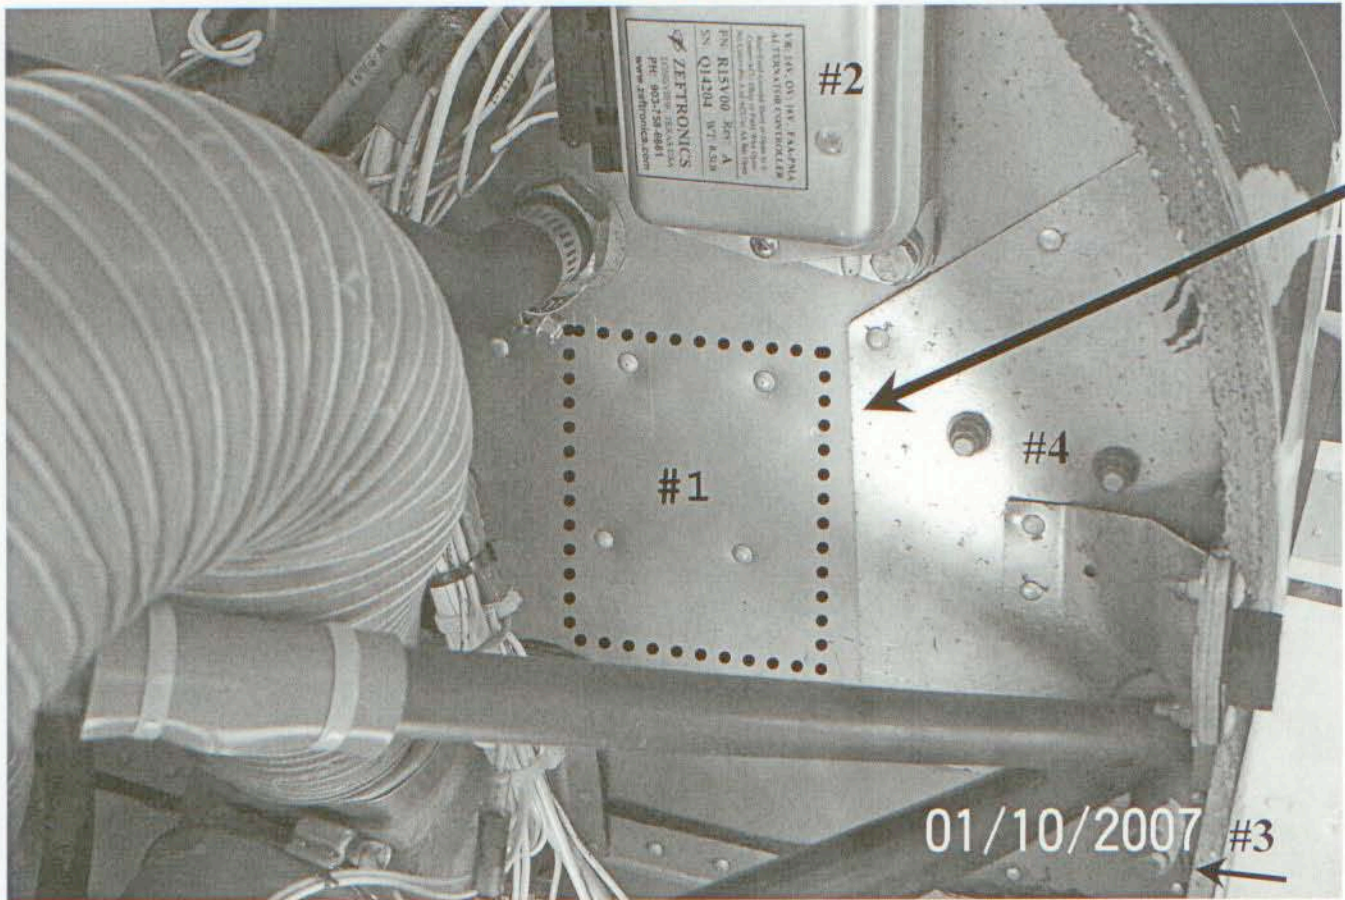
Above photo depicts upper portion of the firewall on pilot's side (port). Photo is looking aft.

-- Long black arrow directs viewer to proposed mounting area for XeVision XV1A ballast.

-- Black dotted square outlines proposed location for XeVision XV1A ballast (#1 in photo). Ballast dimensions are: 3.5"L x 3.03"W x 1.26"D.

-- Rivets within proposed mounting area secure lightened firewall doubler located on cabin side of firewall.

-- Proposed mounting area is approximately two (2) inches below Zeftronics voltage controller (#2 in photo) and approximately five and one half (5 1/2) inches inboard of the port side upper engine mount attaching station (#3 in photo).

-- The two nuts visible between the proposed mounting position and the outer fuselage are two of the three nuts securing the port side aileron cable pulley (#4 in photo).
