US Department of Transportation Federal Aviation Administration	<b>MAJOR REPAIR AND ALTERATION</b> <b>(Airframe, Powerplant, Propeller, or Appliance)</b>			Forms Approved OMB No. 2120-0020 11/30/2007	Electronic Tracking Number _____
	For FAA Use Only				
INSTRUCTIONS: Print or type all entries. See Title 14 CFR §43.9, Part 43 Appendix B, and AC 43.9-1 (or subsequent revision thereof) for instructions and disposition of this form. This report is required by law (49 U.S.C. §44701). Failure to report can result in a civil penalty for each such violation. (49 U.S.C. §46301(a))

1. Aircraft	Nationality and Registration Mark N1148G		Serial No. 24-1205		
	Make Mooney		Model M20J	Series 201	
2. Owner	Name (As shown on registration certificate) Pinzon, Pablo A. Jimenez, Craig R. Energetic Materials of Oklahoma, L.L.C.		Address (As shown on registration certificate) Address: 1601 S.W. 89th St STE D100		
			City: Oklahoma City State: OK	Zip: 73158-6378 Country: USA

**Instructions for Continued Airworthiness  
for  
Mooney M20J SN: 24-1205 N1148G  
April 21, 2008**

**XeVision (HID) landing Light System**

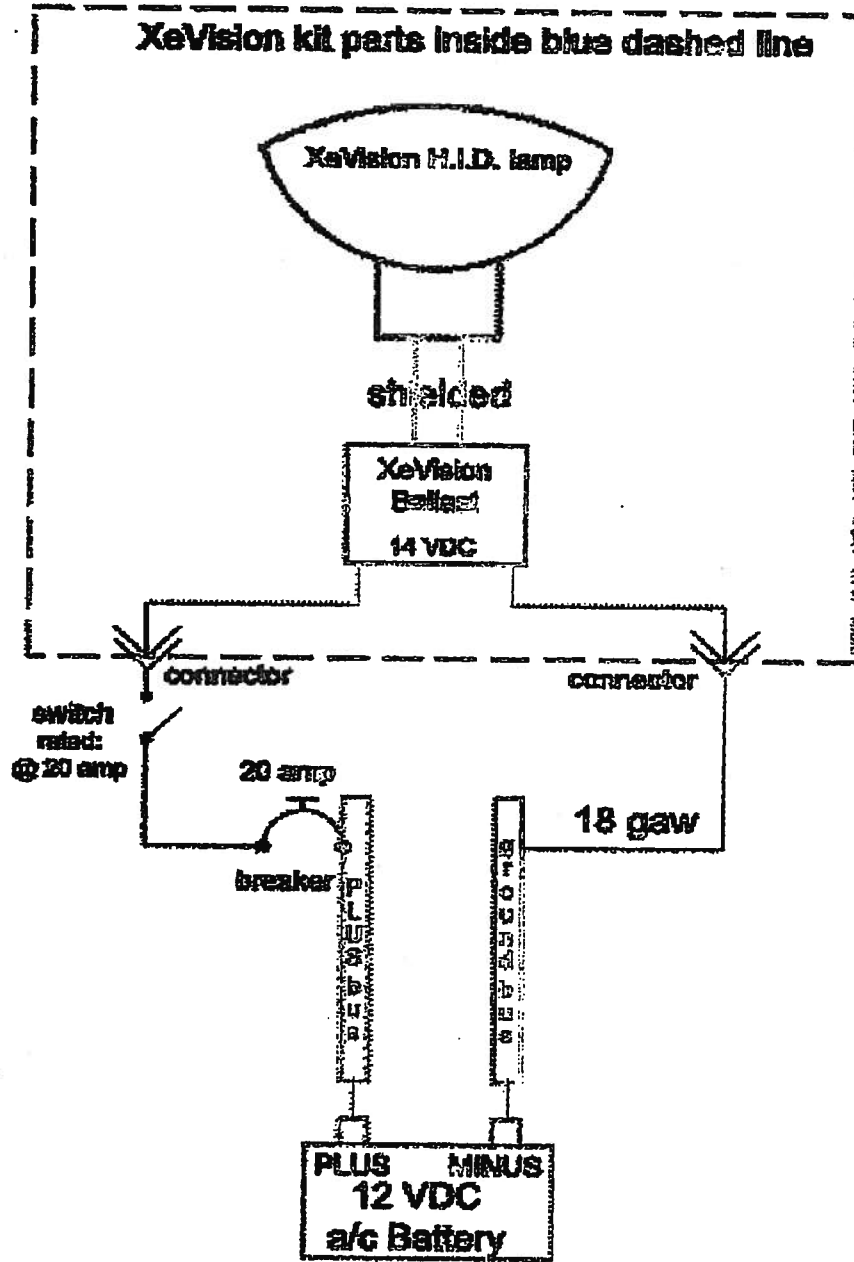
Basic Wiring 12 VDC diagram example

2.3 The existing landing light switch is used, an inline 15 amp fuse is installed near the switch in the existing landing light wire to the XeVision ballast on the firewall. The existing wiring from the switch to the ballast exceeds the requirement of the new light. New light and Ballast do not interfere with aircraft avionics or any other system in the aircraft. Electrical load is less than original landing light. Ballast steady state current draw is less than 4 amps. Maximum current when light is switched on is 10 amps.

2.6 Electrical Schematic drawing and Instructions for Continued Airworthiness (ICA) are attached.
