MAJOR REPAIR AND ALTERATION (Airframe, Powerplant, Propeller, or Appliance)

Make: Piper Model: PA-28R-200 Serial: 28R-35698 Registration: N4979S Total Time: 2886.94 Date: 03-18-2002

Instructions for Continued Airworthiness

with XeVision H.I.D. Replacement Taxi Light in LoPresti Cowl

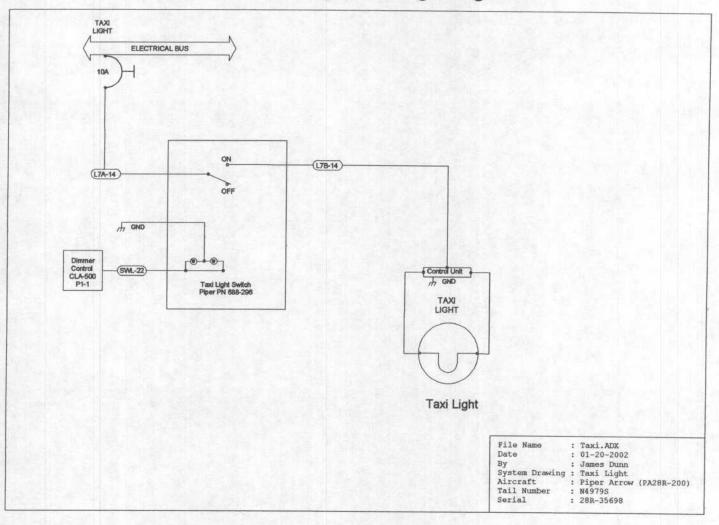
Taxi Light Wiring Diagram

- 2. **Description**: A XeVision H.I.D. light was installed in replacement for one Par36 taxi light mounted in lower center of cowling. The ballast was mounted on right hand side of the firewall used existing wire and install a 10 Amp circuit breaker and a piper lighted switch 688-296 out of a newer piper arrow

Replaced PAR36 light in cowl with XeVision kit # XV-36-SL H.I.D. used existing wire Mounted ballast on firewall upper left side station # 49 with 4) AN3-4A bolts, 4) AN960-10 Washers, 4) MS21044N08 Nuts. Installed a 10 Amp circuit breaker MS-26574-10 mounted in instrument panel on master bus and MS22759/16-14 wire. Installed Piper Taxi Light switch PN: 688-296. This work was accomplished using XeVision installation and operations manual 04-17-2002. There were no adverse effects with any of the other aircraft systems. In testing the equipment load with a amp probe the following loads where found: Load at startup was 6.29 Amps for 7 seconds after 7 seconds the load during normal operation was 3.25 Amps.
