8. Description of Work Accomplished

C177B 17702359 N999HR 1/10/2007 2309 tach Hrs.

N999HR ser.# 17702359 • Cessna Cardinal 177B • 2309 tach hrs. • 1/10/2007

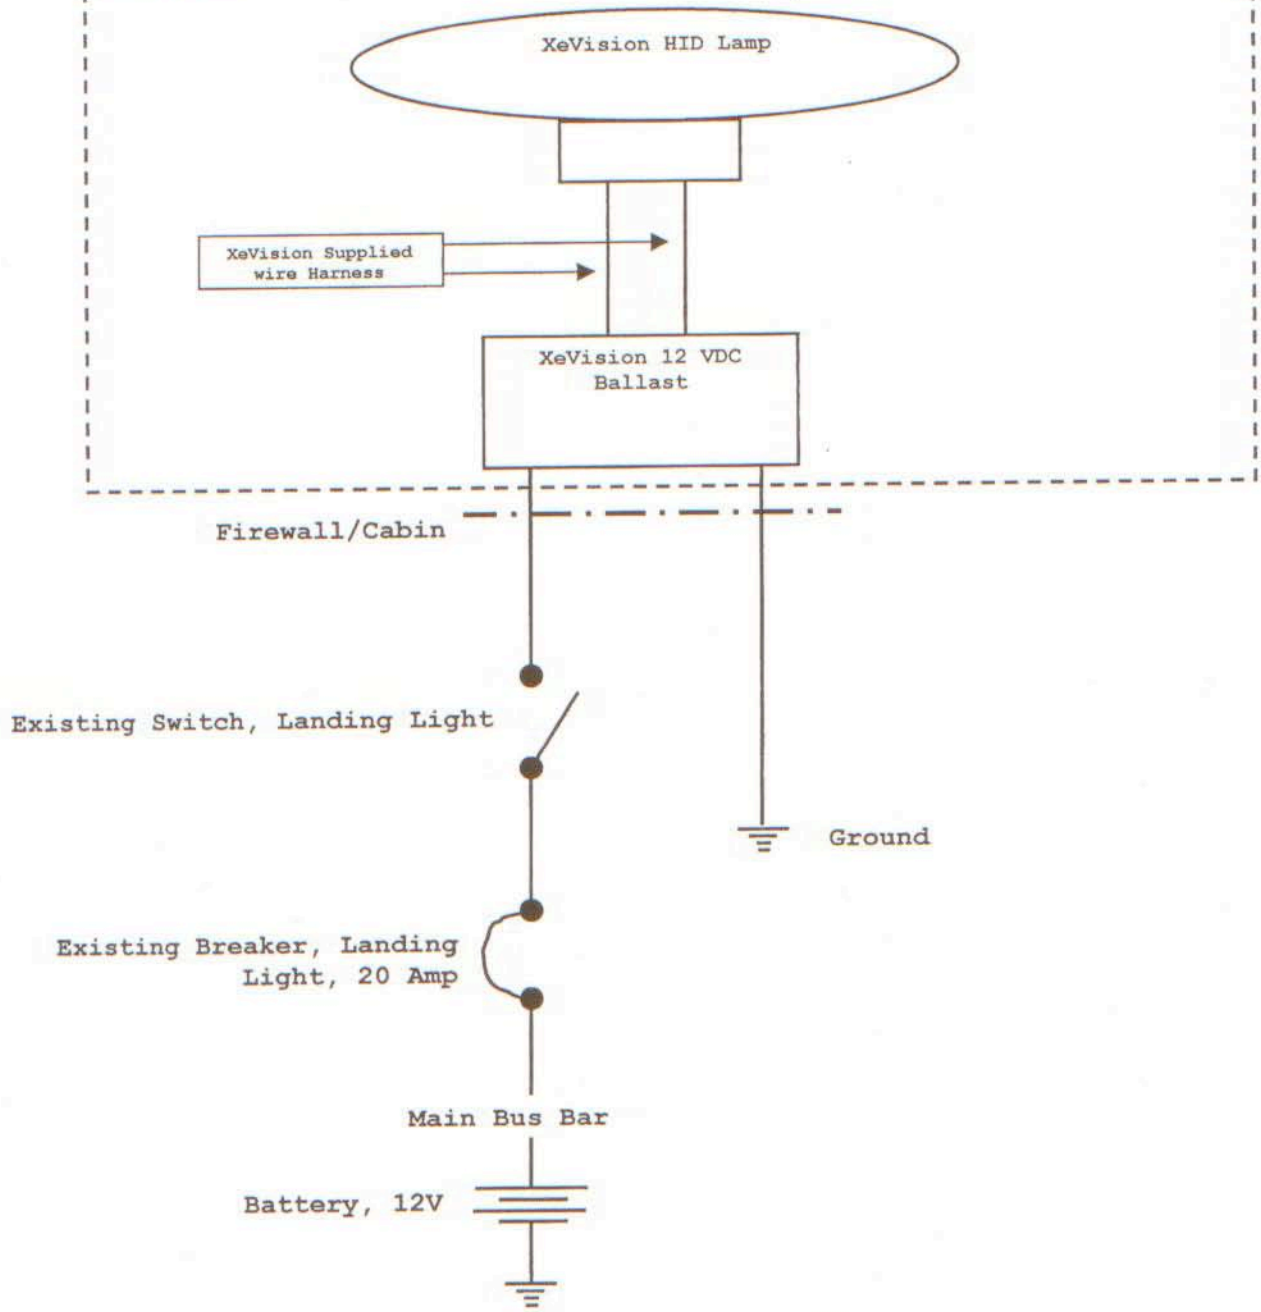
XeVision Landing Light Kit Parts XV-46-SL contained within this box.

Installed Aero Visions International, Inc. XeVision 14V Landing Light Kit XV-46-SL using existing wiring and existing structure not altered.
