MAJOR REPAIR AND ALTERATION (Airframe, Powerplant, Propeller, or Appliance)

1. Aircraft	Nationality and Registration Mark United States of America N7284L	Serial No. AA5-0284	
	Make Grumman American	Model AA-5	Series Traveler
2. Owner	Name (As shown on registration certificate) Alvin G. Griffin Nancy L. Griffin	Address (As shown on registration certificate) Address 28410 Charles Street	
		City Mechanicsville, State MD	Zip 20659-3455 Country U.S.A.

1. INTRODUCTION: This installation was accomplished to gain better landing light illumination and to increase the service life of the landing light. This light provides increased illumination levels while using half of the power of the light it replaces. An electrical load analysis is attached.

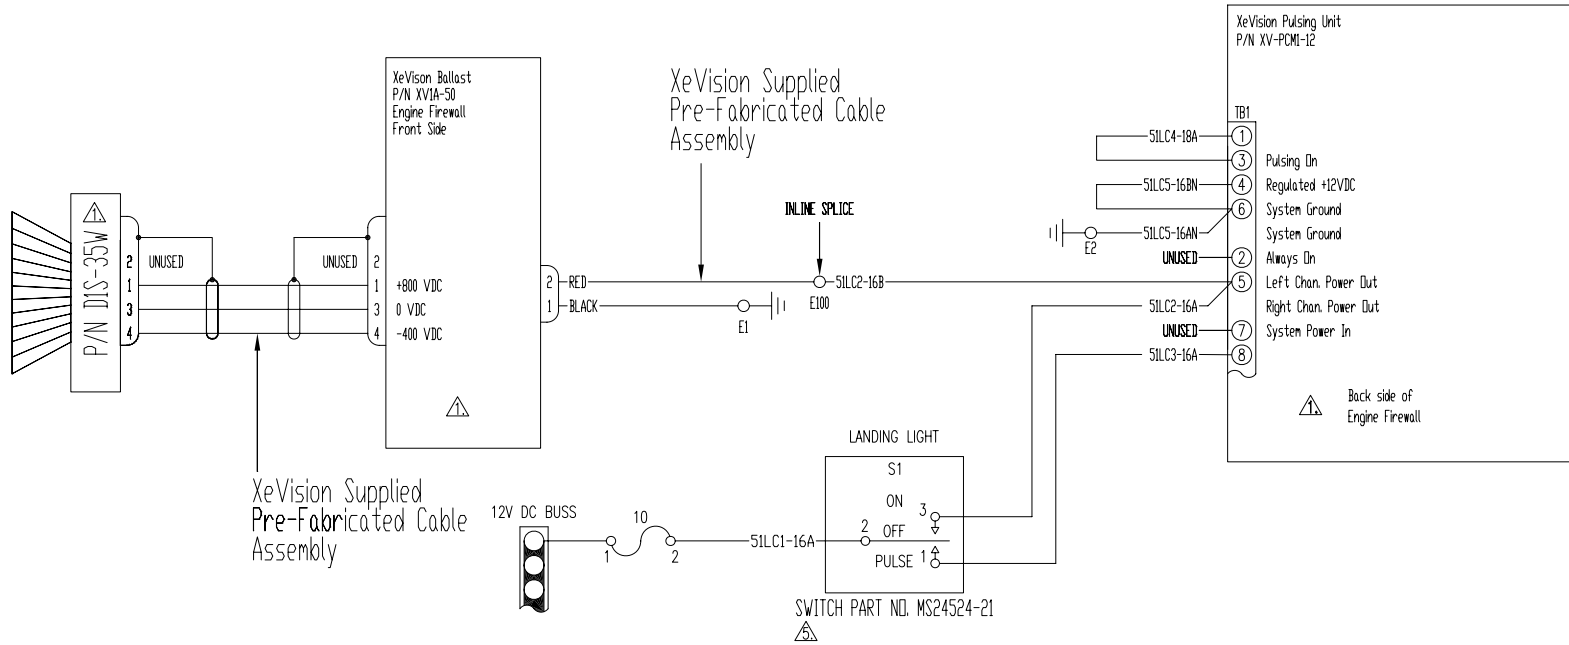
- 1. P/N's current at time of installation. Replacement parts shall be same or suitable current replacement P/N specified by Aero Visions International, Ogden, UT marketer of XeVision Lighting Products. (801) 622-7000. www.xevision.com
- 2. At a minimum, each wire shall be marked with a wire number sleeve located a maximum of 6 inches from each end. If wire marking equipment is available, wire will be marked at a maximum of 10 inch intervals along the wire.
- 3. Wiring practices shall be IAW SAE A550881, Latest revision.
- 4. Newly installed wire shall be MIL-W-22759/16, MIL-W-22759/34, or MIL-W-22759/43. The /43 wire is the preferred wire for its heat rating in the engine compartment
- 5. Install jumper wires between terminals 1&4, 2&5, and 3&6 in addition to connections shown on drawing for circuit redundancy.

7. REMOVAL & REPLACEMENT INFORMATION: The HID lamp is removed and installed in the same manner as the original lamp.
8. DIAGRAMS: Access to the lamp and ballast is by removing the cowling. See attached diagram for wiring schematic and component locations.
