MAJOR REPAIR AND ALTERATION (Airframe, Powerplant, Propeller, or Appliance)

1. Aircraft	Nationality and Registration Mark N74615	Serial No. AA5B	
	Make Grumman American	Model AA5B-0286	Series
2. Owner	Name (As shown on registration certificate) Robert Nuss		Address (As shown on registration certificate) Address 6871 W. 1350 N.
			City DeMotte State IN
			Zip 46310 Country US

7. Removal and replacement information: The HID lamps are removed and installed in the same manner as the original lamps.
8. Diagrams: Access to the lamps and ballasts are by removing the cowling. See XeVision wiring diagram no. 104406 for details of wiring.

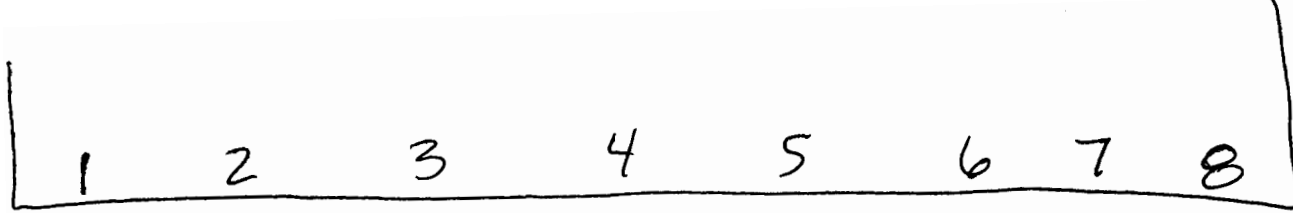
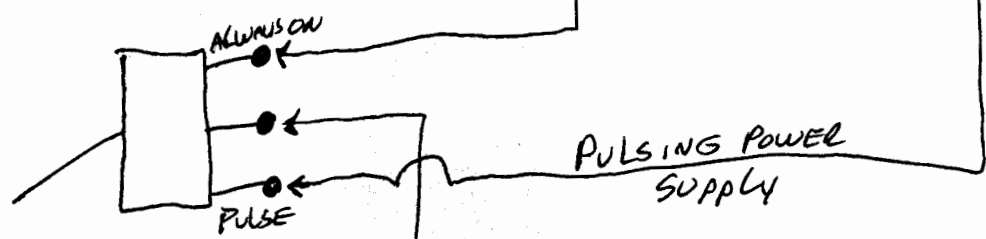
SMALL WIRE #16 or #18

AIRCRAFT GROUND

Ballast Converter

12V TO BALLAST

GROUND

ALWAYS ON POWER SUPPLY

POWER IN FROM BREAKER OR FROM MAIN LANDING LIGHT SWITCH
